CROSS RIVER DAM
WESTCHESTER COUNTY
NEW YORK

INVENTORY NO 38

PHASE I INSPECTION REPORT
NATIONAL DAM SAFETY PROGRAM

NEW YORK DISTRICT CORPS OF ENGINEERS
AUGUST 1978

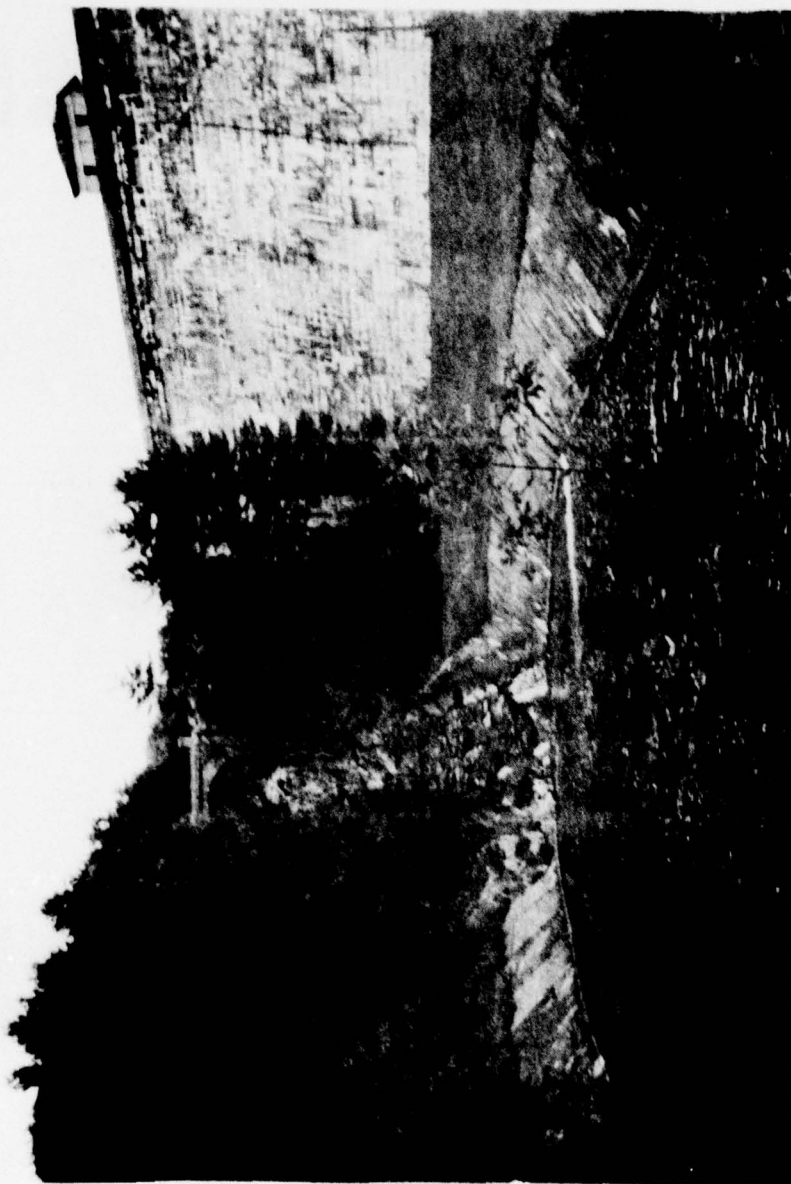
Overview of dam showing concrete block faced
cyclopean masonry structure constructed in
1906. Side channel rock spillway is founded
on north abutment.

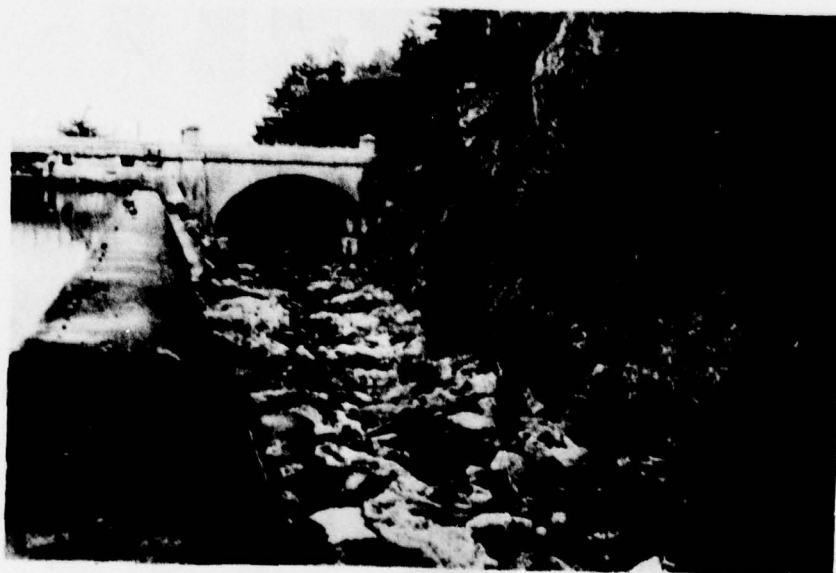
16. View down spillway side channel.

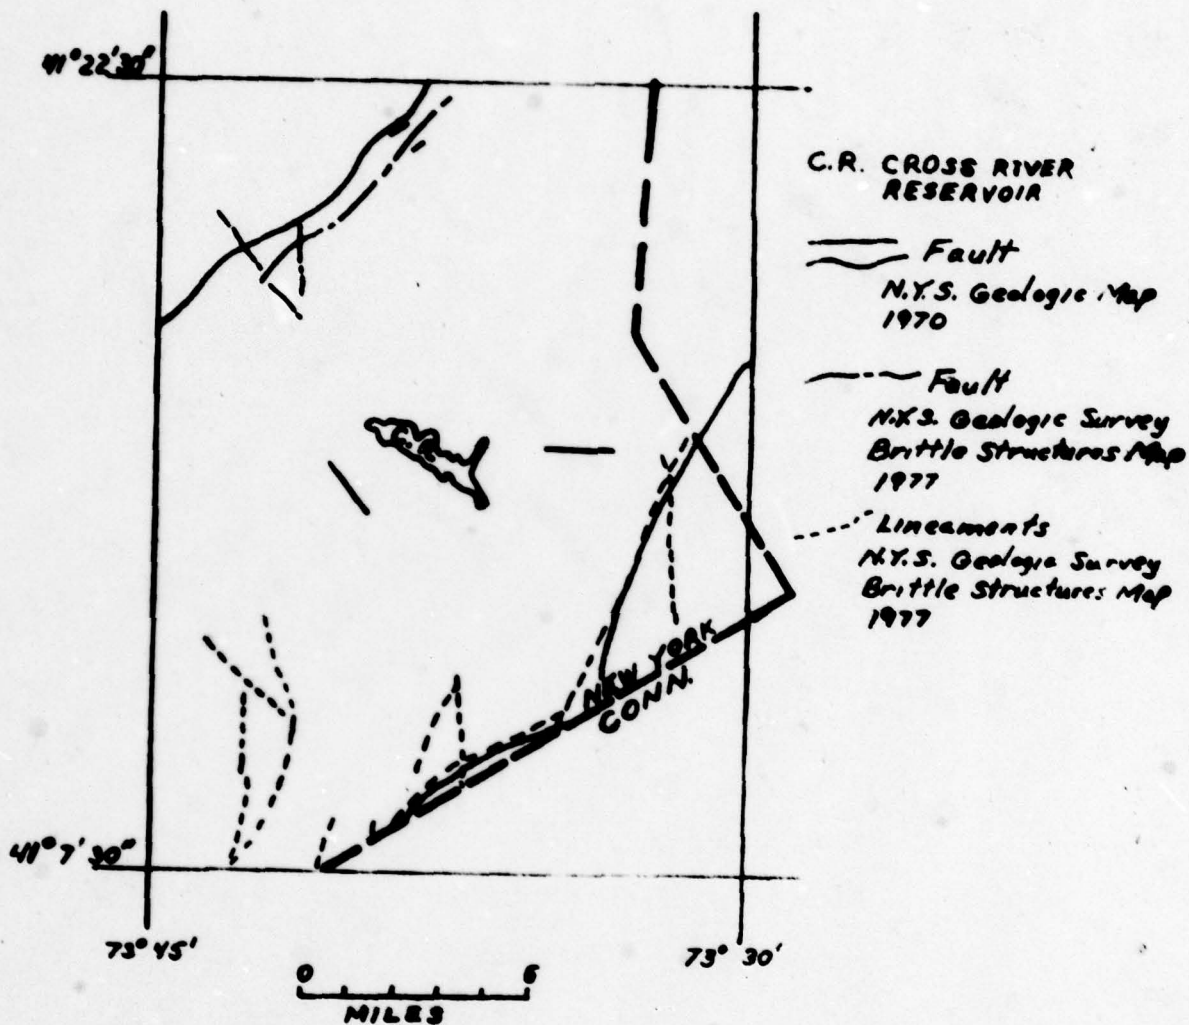
GEOLOGIC MAP
FIGURE 26

The State Geologic map indicates several faults present in the area. None are known to exist in the immediate vicinity of the dam or the spillway. See Geologic Map Figure 26.
